**HARRIS POND DAM**

**NH 00122**

**PHASE I INSPECTION REPORT  
NATIONAL DAM INSPECTION PROGRAM**

**FEBRUARY 1979**

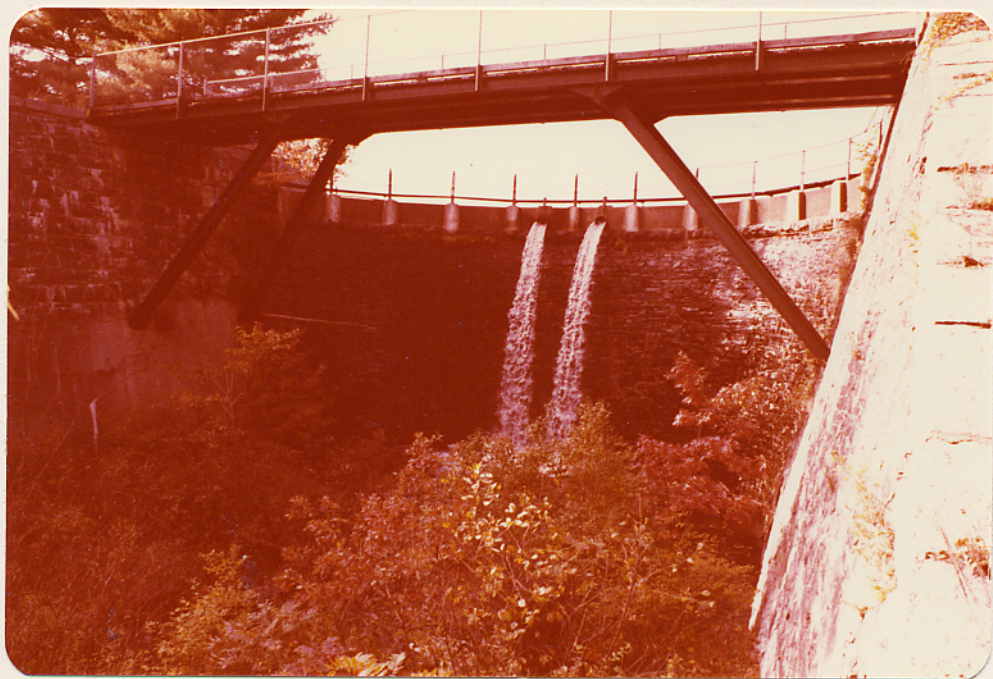
Overview of dam from downstream channel

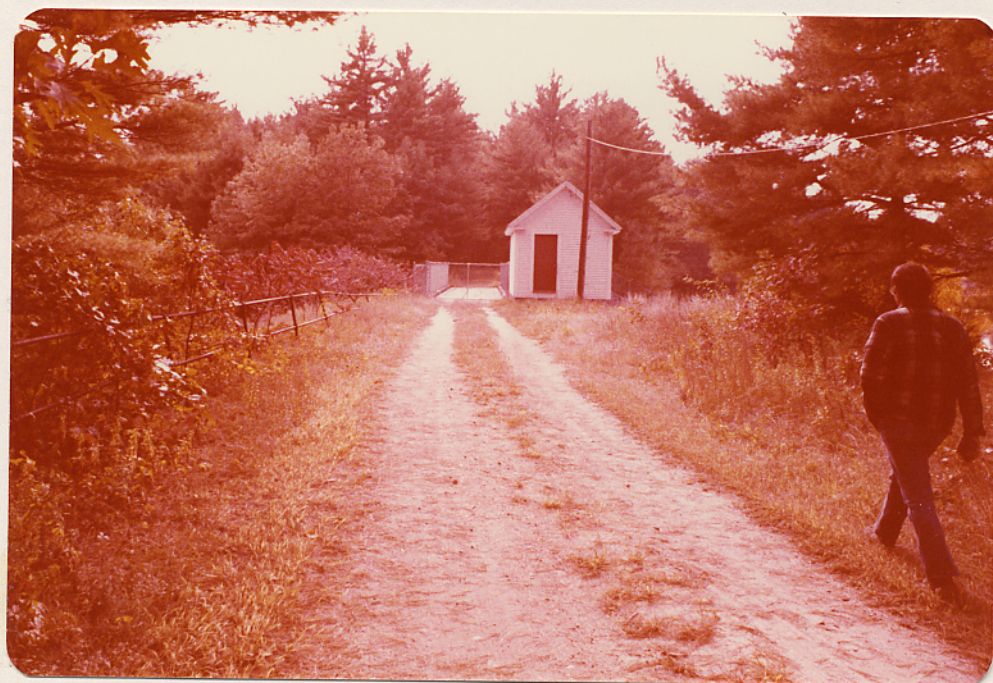
Overview of top of dam from left abutment

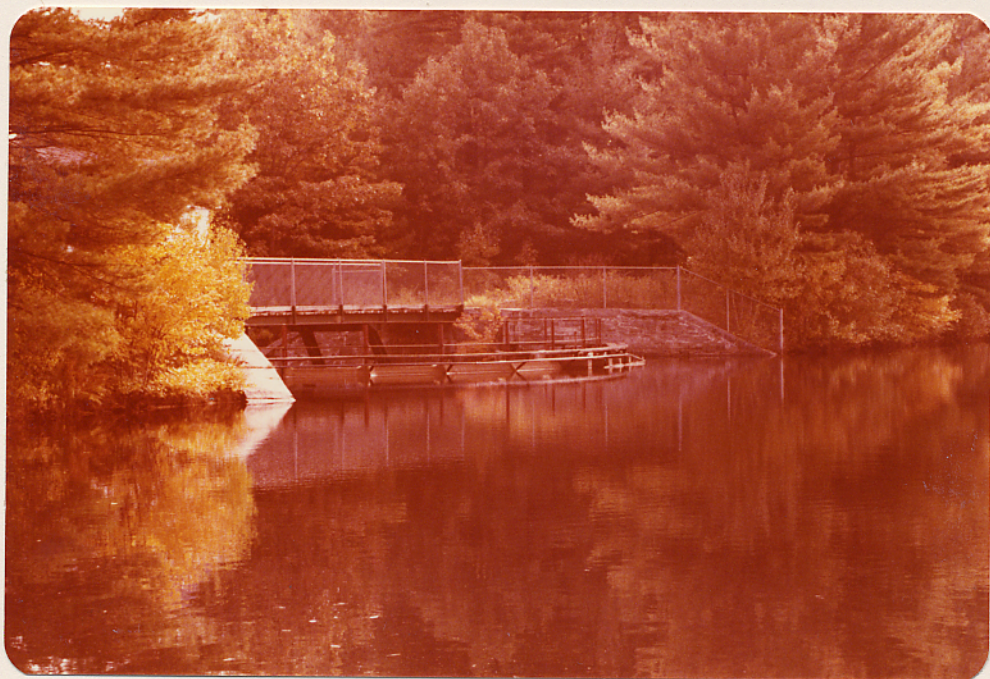
Overview of dam from upstream left side

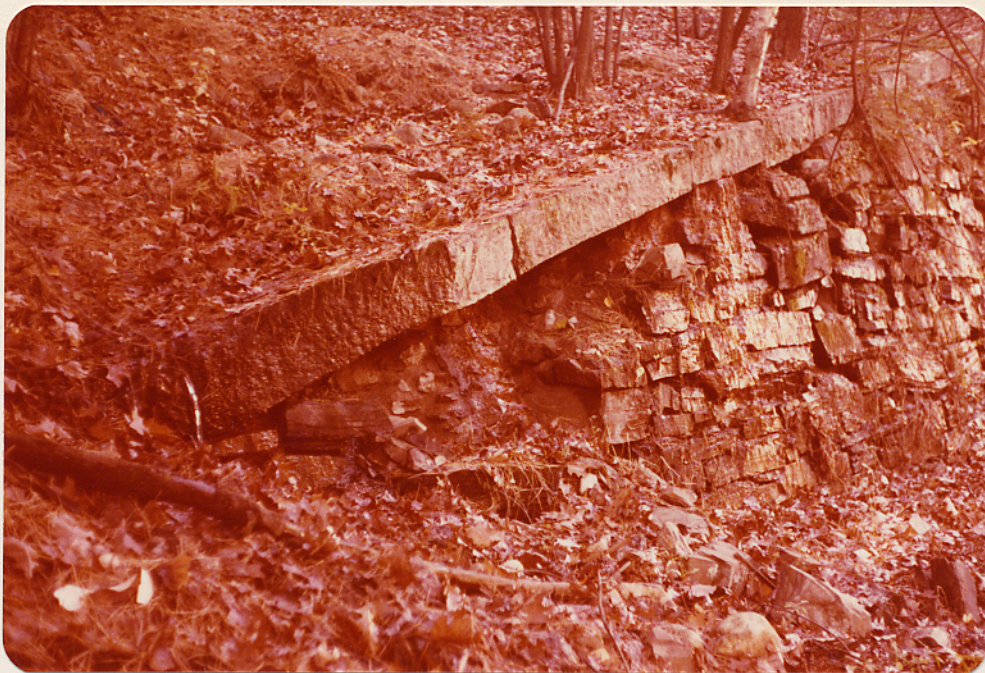
The general condition of the embankment is good. No deficiencies in the vertical and horizontal alignment were noted. No sloughing or erosion of slopes was noted, and the condition of the abutments was good. Seepage at the rate of 5 to 10 gpm at the toe of the right embankment was noted; the water was clean and clear. Considerable heavy brush and trees up to 18 inches in diameter were noted on both the upstream and downstream slopes.

1. View of seepage at base of right downstream training wall

It is recommended that the seepage emanating from the toe of the right embankment and right downstream training wall should be investigated by a qualified geotechnical engineer. Based on this investigation an appropriate design to protect the toe from erosion should be instituted.

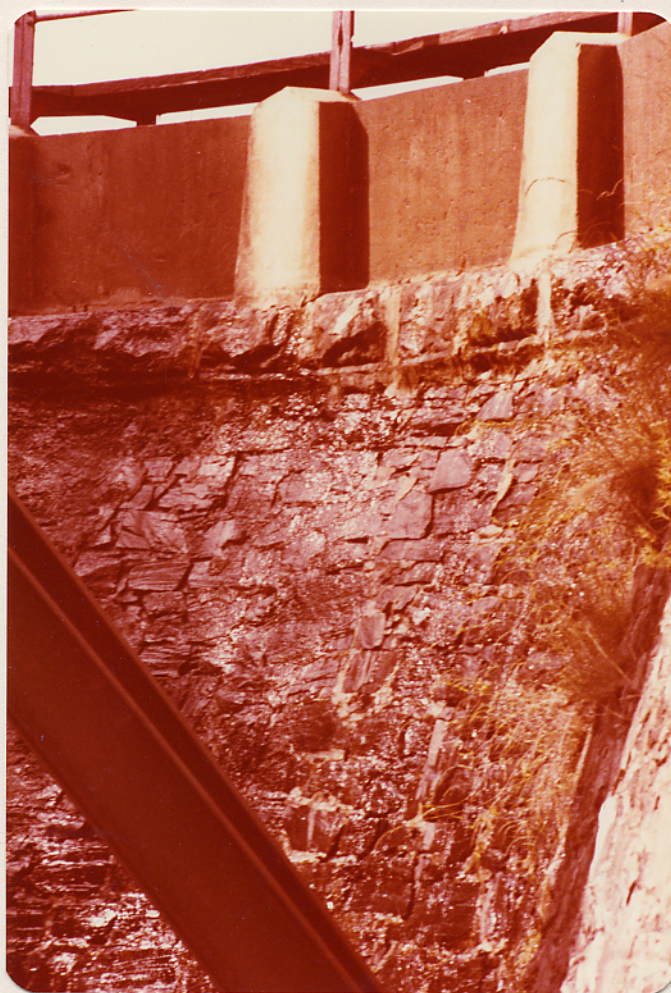
Observations of the cemented stone arch type spillway with its 2.9 foot high concrete cap have revealed seepage between the bottom of the concrete cap and the top of the cemented stone masonry. In some instances there is seepage through the open joints of the stone masonry. It is estimated that at least 50% of the joints in the spillway are void of mortar. The condition of the concrete cap of the spillway is good. The sluice gates are well maintained. The catwalk around the perimeter of the spillway is in good condition. This catwalk is not a debris catcher. The two-inch P.V.C. water pipe which is used to aerate the reservoir surface to prevent ice build up is broken and separated adjacent to the left abutment.

2. View from left downstream training wall of leakage between top of original dam and newer concrete spillway

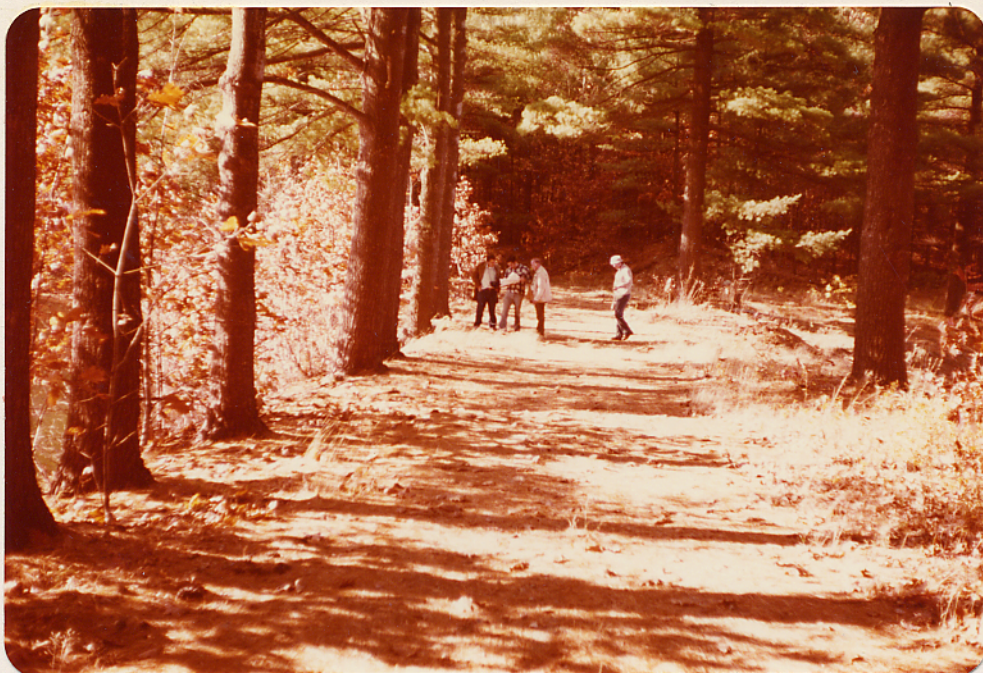
The general condition of the west dike is good. No deficiencies in the vertical and horizontal alignment were noted. No seepage, sloughing, or erosion of the slopes was noted. However, heavy growth, including trees up to 24 inches in diameter, was noted on both the upstream and downstream slopes.

3. View of dike on right side of reservoir to fill in natural low area

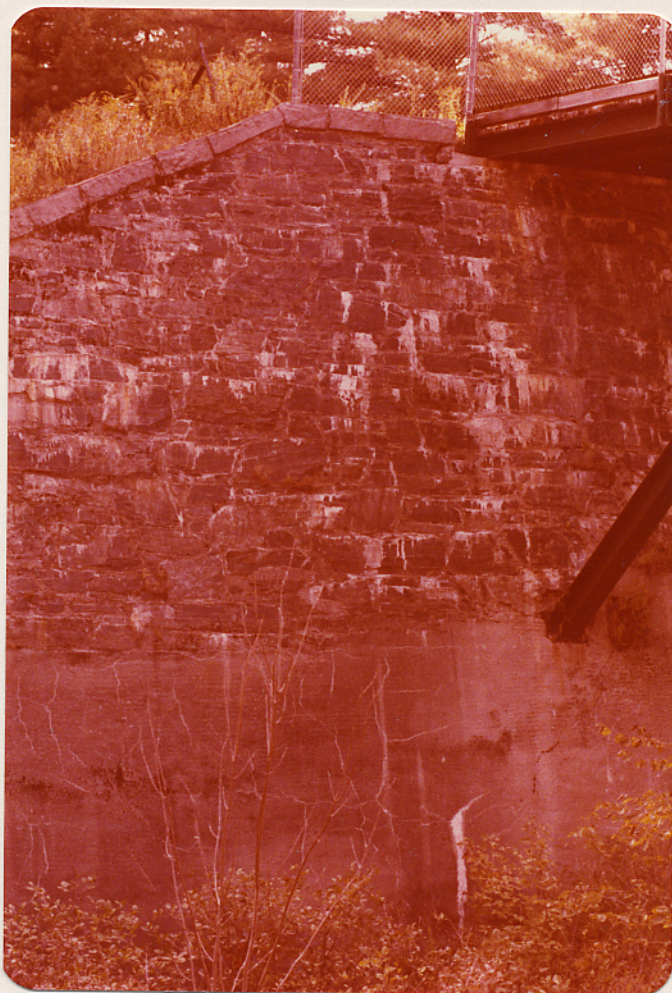
Loose mortar and efflorescence occurs over approximately 50% of the wall face. The abutment and the entire downstream continuation of this abutment has been faced with gunite from the channel bed to a height of approximately 15 feet. This gunite facing exhibits large, random cracks and is completely efflorescenced which can be attributed to seepage. This mortar facing was applied to the abutment and downstream training wall to arrest seepage. There is considerable amount of vegetation at the connection between the spillway and this abutment.

4. View of right abutment from downstream channel showing cracks in concrete facing at base of wall
